## MOUNT COMFORT GATEWAY CORRIDOR STELLAR IMPROVEMENTS

*Target Projects for New Palestine*

September 18, 2018

## NICHOLS BUILDING – EXTERIOR FAÇADE CONDITION ASSESSMENT

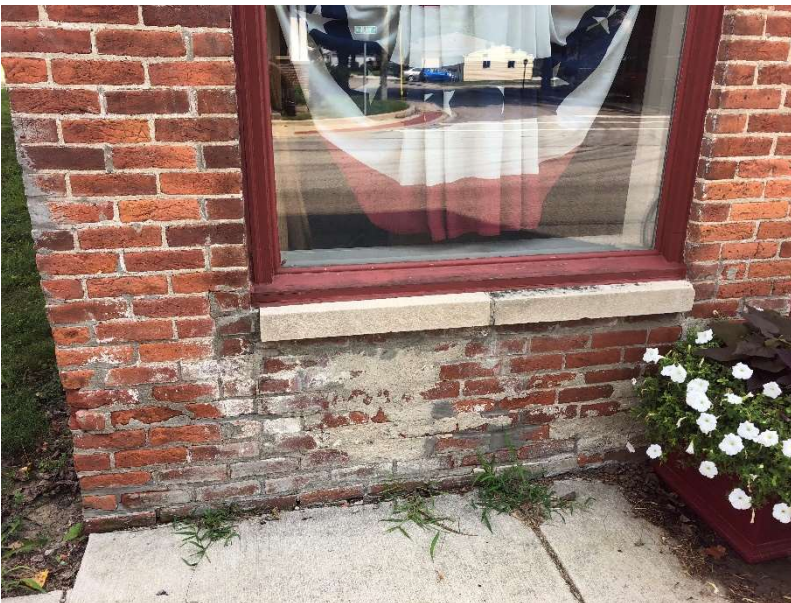
**Photograph No. 2****Description:**

View of east window on north  
façade.

- Spalling of brick masonry
- Parge material
- Efflorescence
- Failing mortar joint at stone sill
- Deterioration of paint at wood window sill

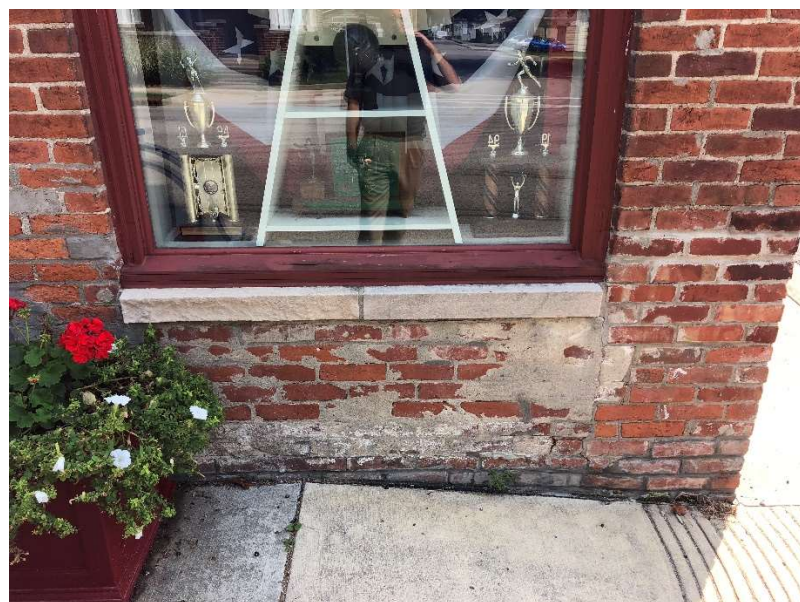
**Photograph No. 3****Description:**

View of north exterior façade west window.

- Spalling of brick masonry
- Parge material
- Efflorescence
- Deterioration of paint at wood window sill
- Vertical crack at edge of window sill

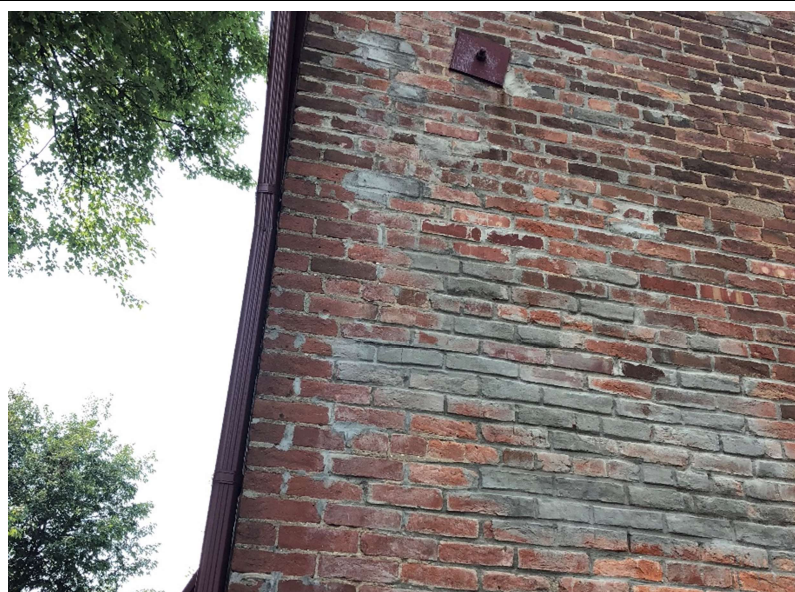
**Photograph No. 5****Description:**

View of south end of east exterior façade.

- Spalling of brick masonry
- Parge material with tooled joints
- Metal rod and plate stabilizer

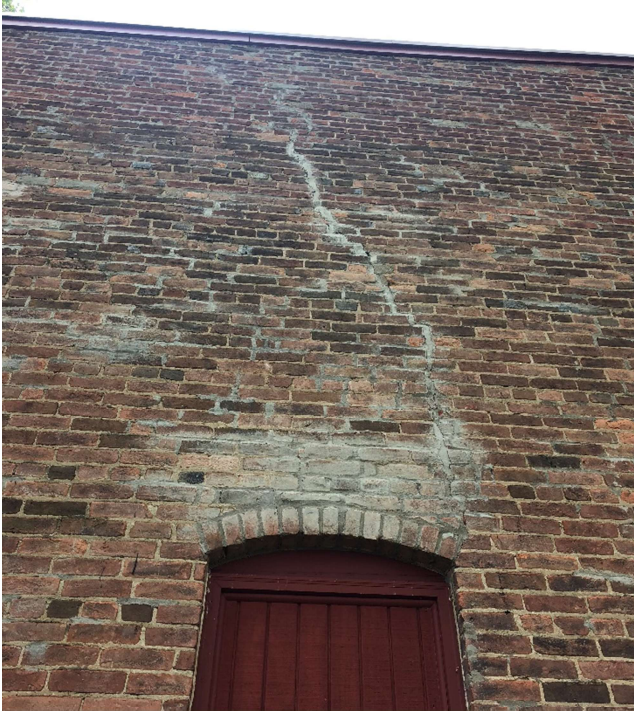
**Photograph No. 6****Description:**

- c. A vertical stepping crack extends from the north edge of the head of the opening stopping just shy of the roof fascia.
  - d. Repeating brick masonry pattern is a Common Bond, with one header course then six running bond courses.

View of window at east exterior façade.

- Spalling of brick masonry
- Parge material with tooled joints
- Vertical stepping crack at window head
- Wood infill at window opening

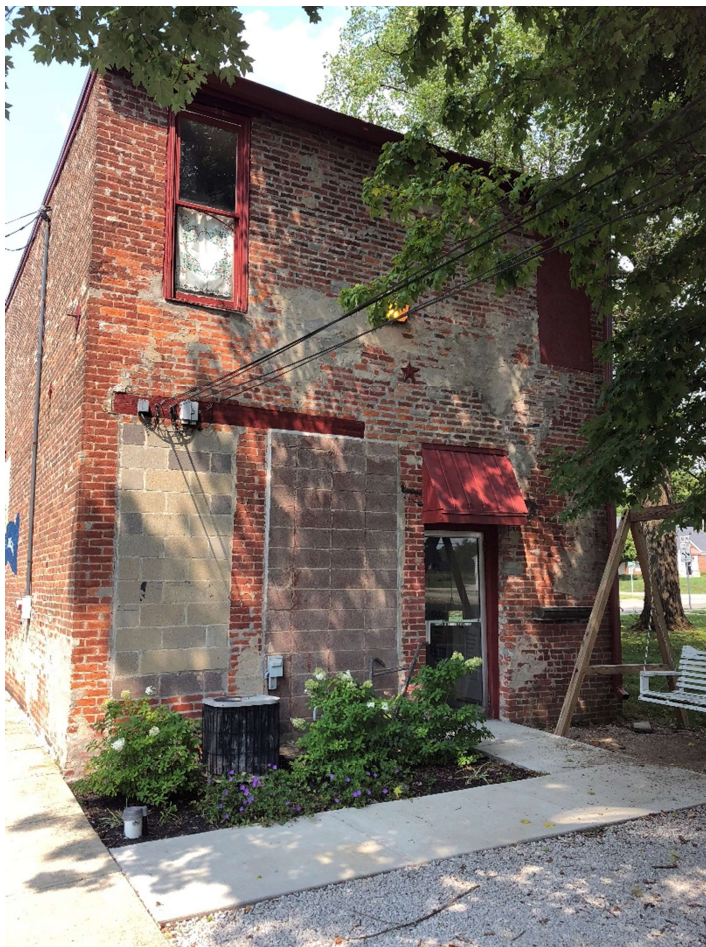
**Photograph No. 7****Description:**

View of south exterior façade.

- Spalling of brick masonry
- Parge material with tooled joints
- Painted wood header
- CMU infill
- Wood infill at window opening

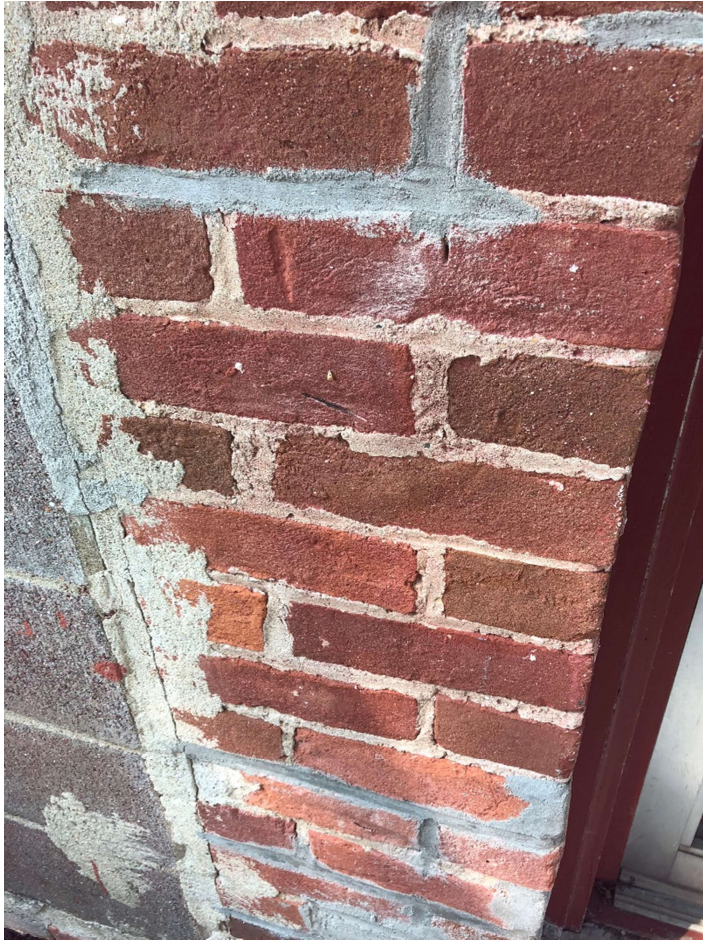
**Photograph No. 8**

- e. Below the wood lintel, two original openings have been infilled with CMU. The mortar joints between CMU and brick masonry have failed due to the differences in expansion/contraction between the two materials.

View of south exterior façade at CMU infill.

- Spalling of brick masonry
- Parge material with tooled joints
- Previous attempt at selective tuckpointing; mismatched mortar color and sawcut of old mortar going too far into brick
- Failing mortar at CMU / brick masonry joint

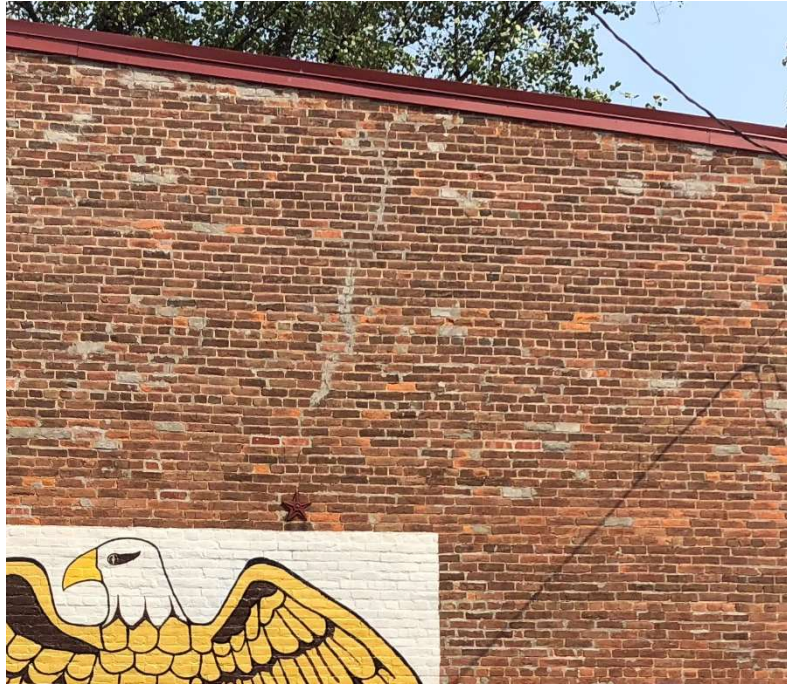
**Photograph No. 10****Description:**

View of west exterior façade.

- Spalling of brick masonry
- Parge material with tooled joints
- Vertical stepping crack from metal star to roof fascia
